PROPER BOTTOM ROW INSTALLATION FOR  
ROSETTA OUTCROPPING BLOCKS

**ROSETTA**  
HARDSCAPES, LLC  
8212 M-119 HARBOR SPRINGS, MI 49740  
877-777-6558 • www.rosettahardscapes.com

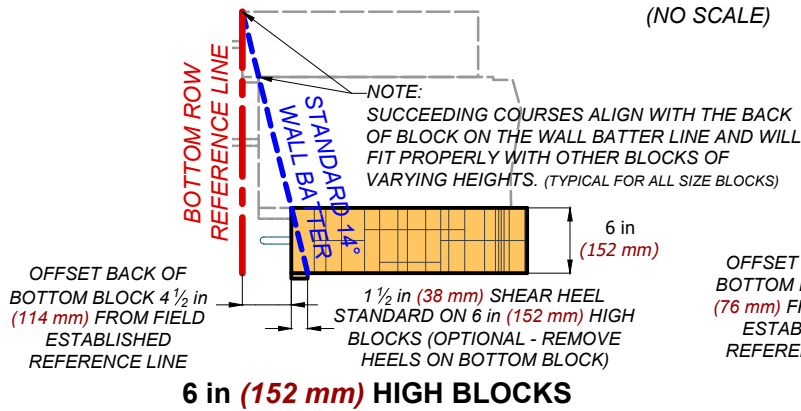
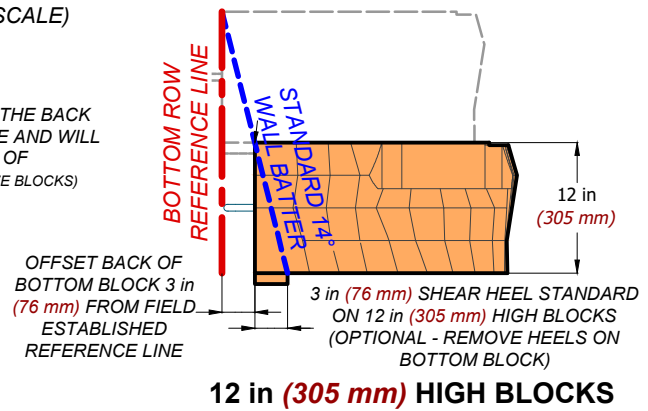
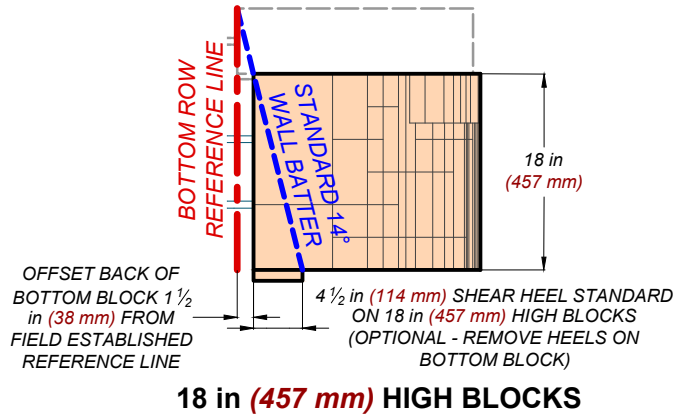
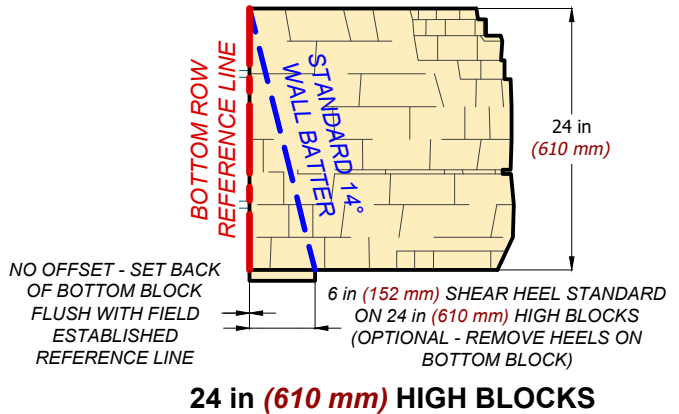
## SIDE VIEWS OF DIFFERENT HEIGHT BLOCKS

(NO SCALE)

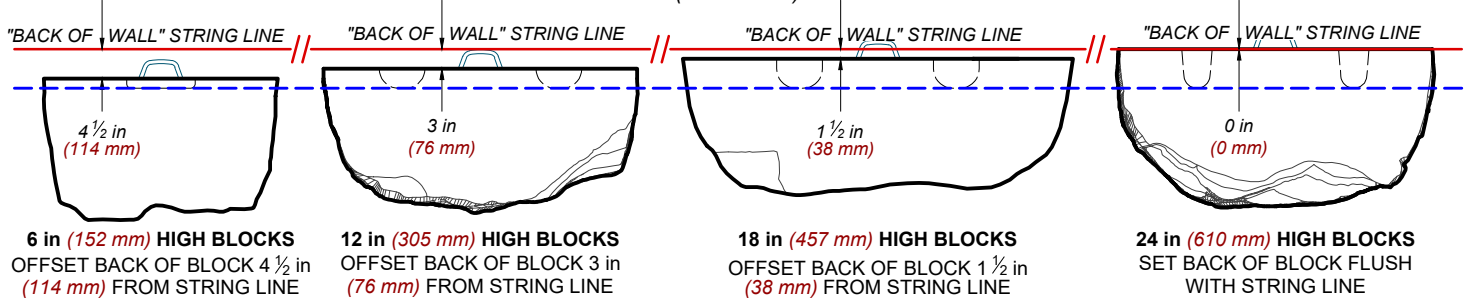
## TOP VIEWS OF DIFFERENT HEIGHT BLOCKS

(NOTE THAT WHEN THE BOTTOM BLOCKS ARE PROPERLY OFFSET, THE FRONT OF THE SHEAR HEELS ARE ALL LINED UP AS IF THERE WERE ANOTHER COURSE OF BLOCKS BENEATH THE STARTING COURSE.)

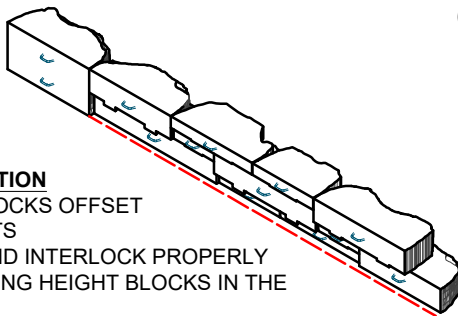
### PROPER INSTALLATION

- BOTTOM ROW BLOCKS OFFSET PER BLOCK HEIGHTS
- BLOCKS ALIGN AND INTERLOCK PROPERLY WITH OTHER VARYING HEIGHT BLOCKS IN THE WALL

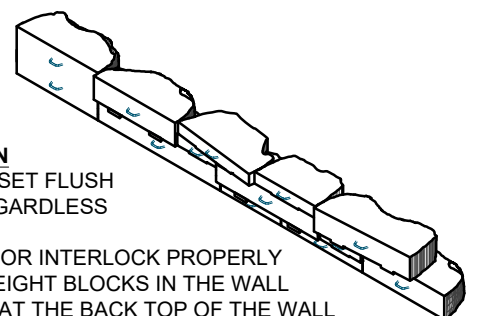
### IMPROPER INSTALLATION

- BOTTOM ROW BLOCKS SET FLUSH WITH THE SAME LINE REGARDLESS OF BLOCK HEIGHTS
- BLOCKS DO NOT ALIGN OR INTERLOCK PROPERLY WITH OTHER VARYING HEIGHT BLOCKS IN THE WALL
- NOTE IRREGULAR LINE AT THE BACK TOP OF THE WALL
